TP 14366E

Tank-Car Thermal Protection Defect Assessment: Fire Tests of 500-Gallon Tanks with Thermal Protection Defects

Department of Mechanical and Materials Engineering
Queen's University
Kingston, Ontario

March 2005

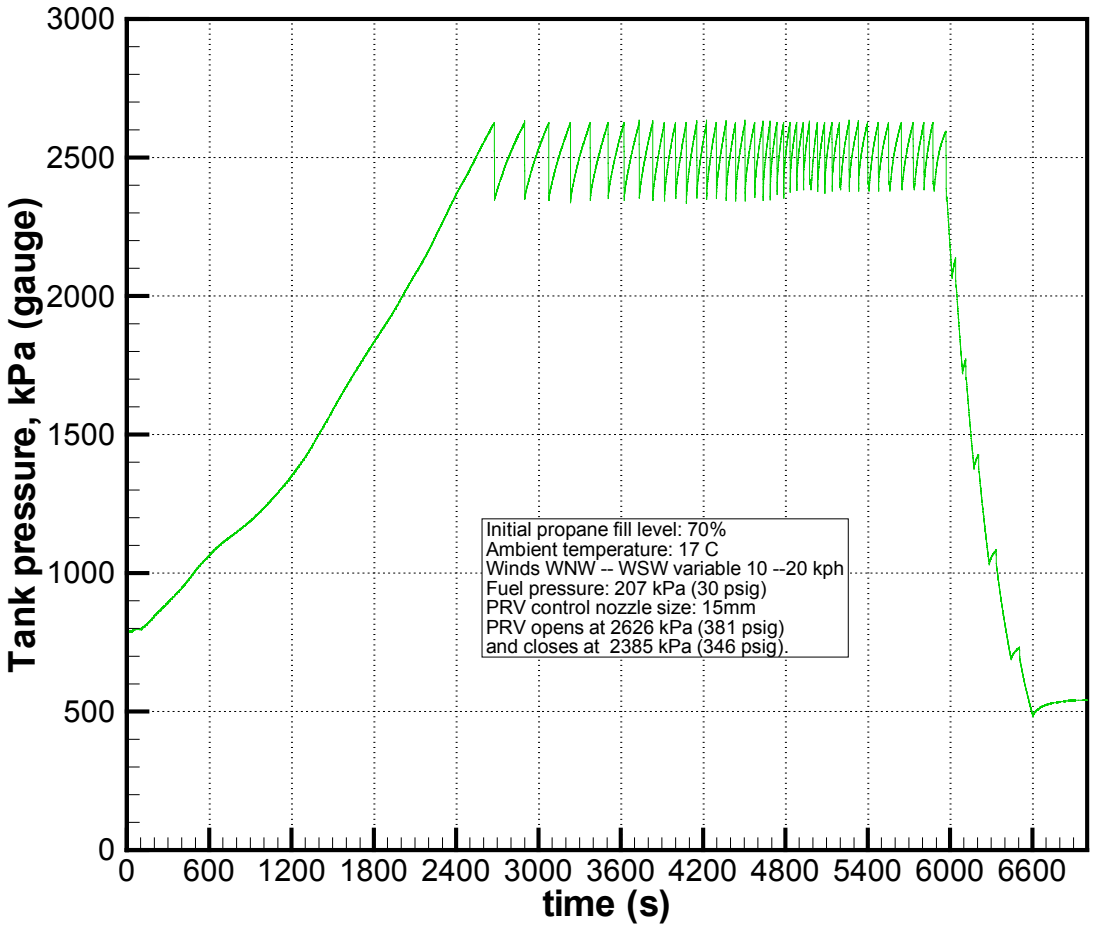
- Steel jacket and insulation
  -16% insulation defect
- PRV setting: 2.63 kPa, 9% blowdown
- Fill level: 71%
- Insufficient fire, no tank failure

Tank pressure, Test 04-2 (jacket, large defect). Run aborted due to insuffcient burner fuel flow.

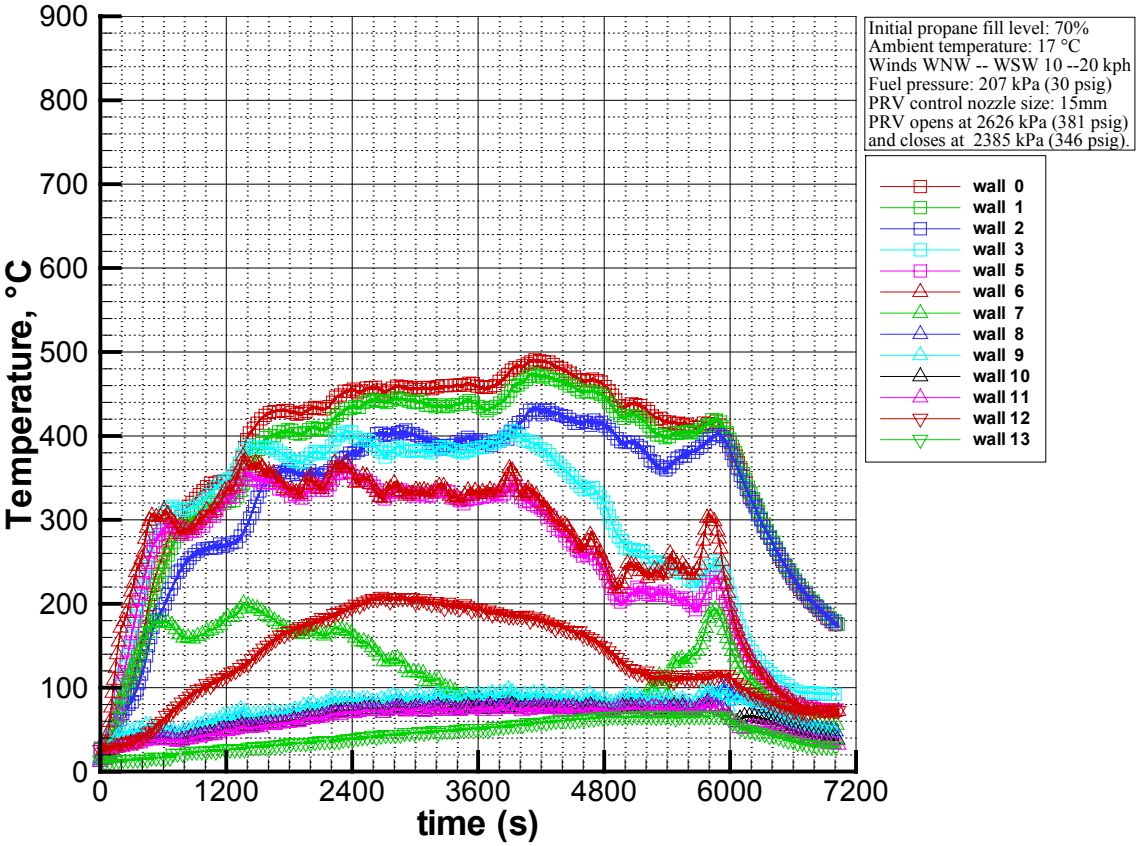
Wall temperature, Test 04-2 (shell, large defect). Run aborted due to insuffcient burner fuel flow.

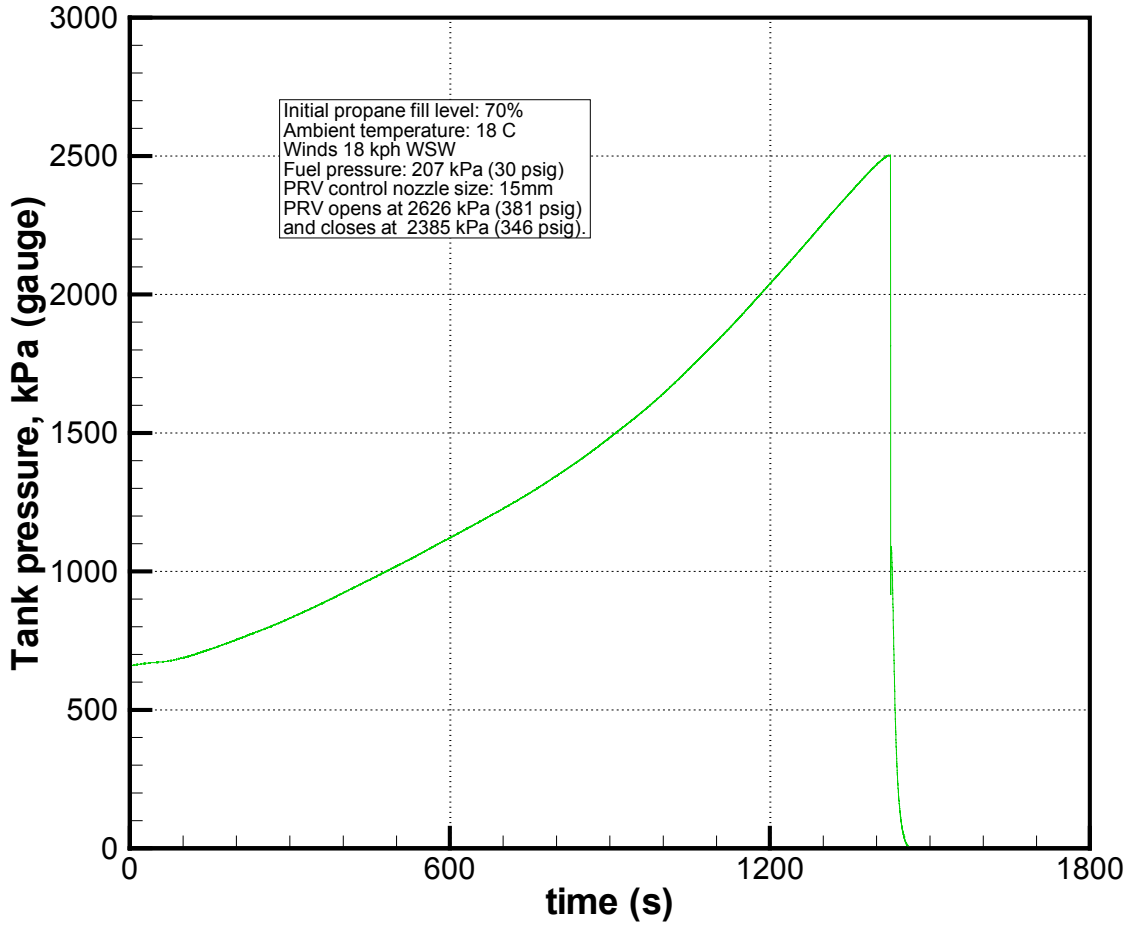
- Steel jacket and insulation
  -16% insulation defect
- PRV setting: 2.63 kPa, 9% blowdown
- Fill level: 71% initial, 71% at failure
- Jet release failure
- Failure at 23.8 min (19.6 min adjusted time)

Tank pressure, Test 04-3 (jacket, large insulation defect).

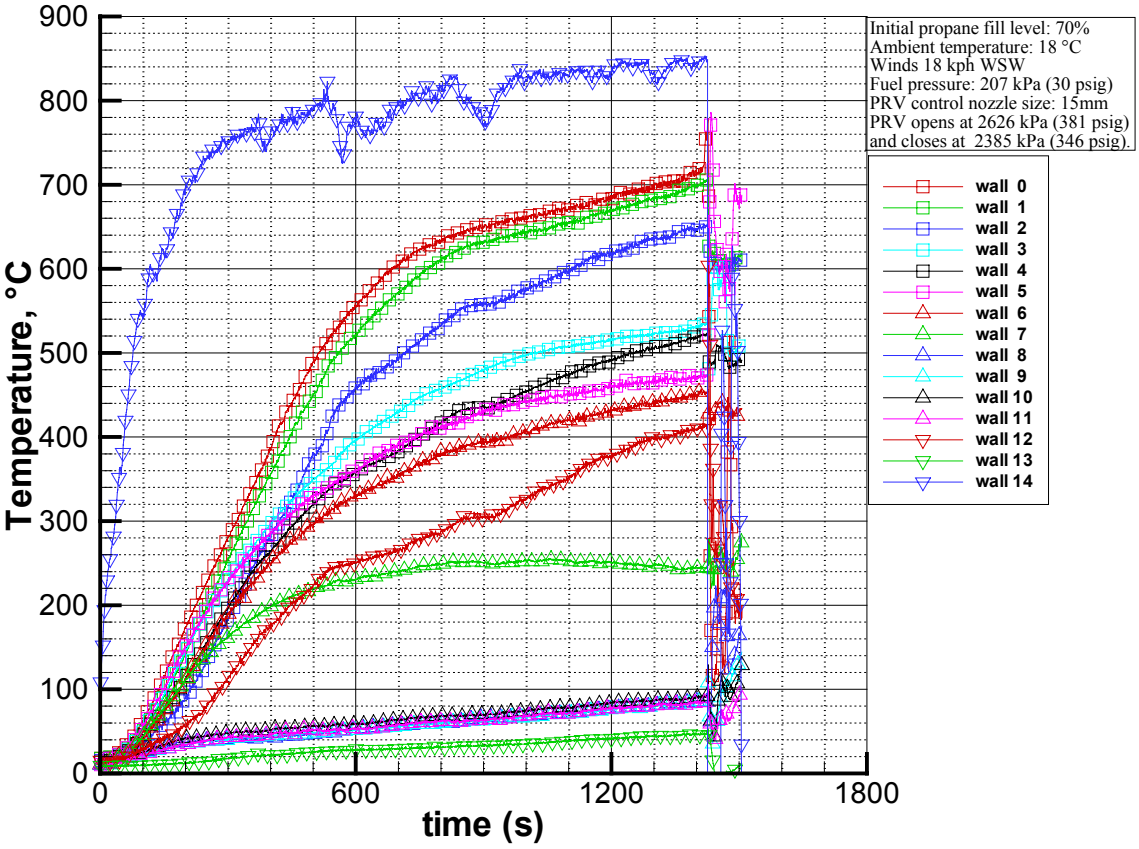
Wall temperature, Test 04-3 (shell, large insulation defect).

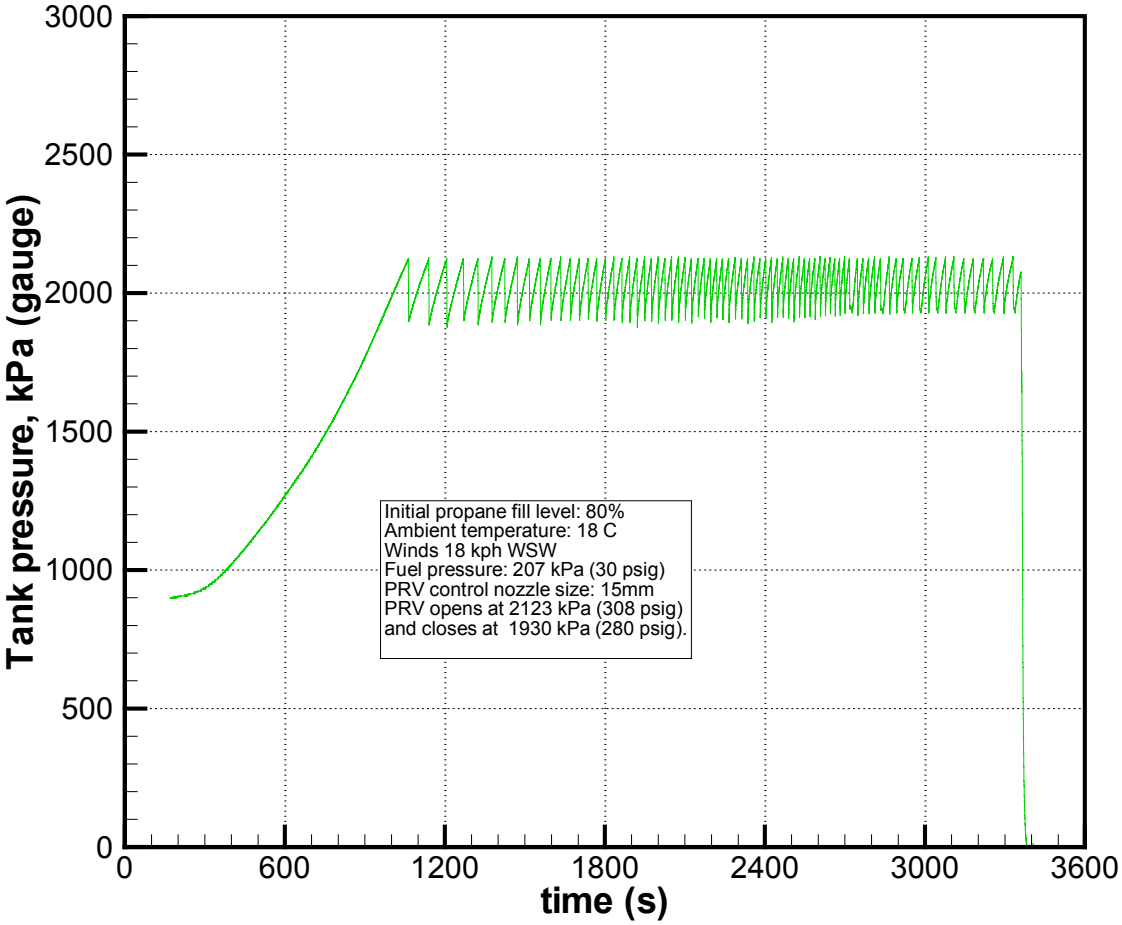
- Steel jacket and insulation
  -16% insulation defect
- Reduced hoop stress
- PRV setting: 2.12 kPa, 9% blowdown
- Fill level: 78% initial, 64% at failure
- Jet release failure
  -Failure at 56.0 min (36.0 min adjusted time)

Tank pressure, Test 04-4 (jacket, large insulation defect, lower hoop stress).
